PASSAIC RIVER BASIN

SYLVA LAKE DAM

PHASE I INSPECTION REPORT  
NATIONAL DAM SAFETY PROGRAM

NJ 00391

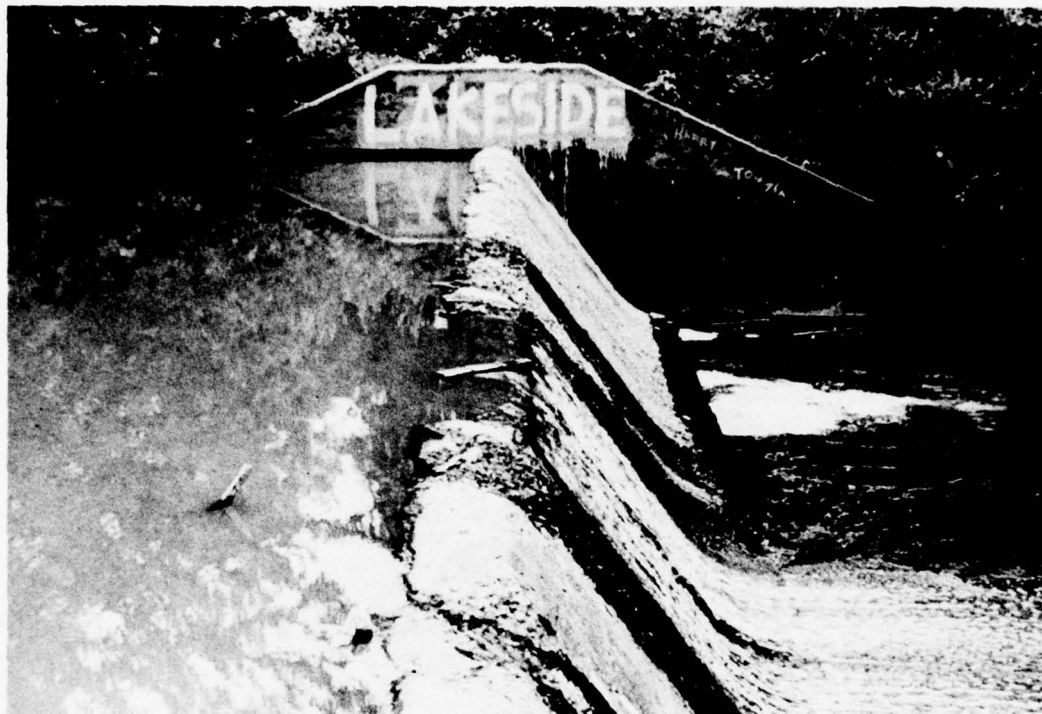
PHOTO 1

Photo 1 - View of Spillway and Left Abutment Wing Wall Looking Toward Northeast - 24 June 1978.

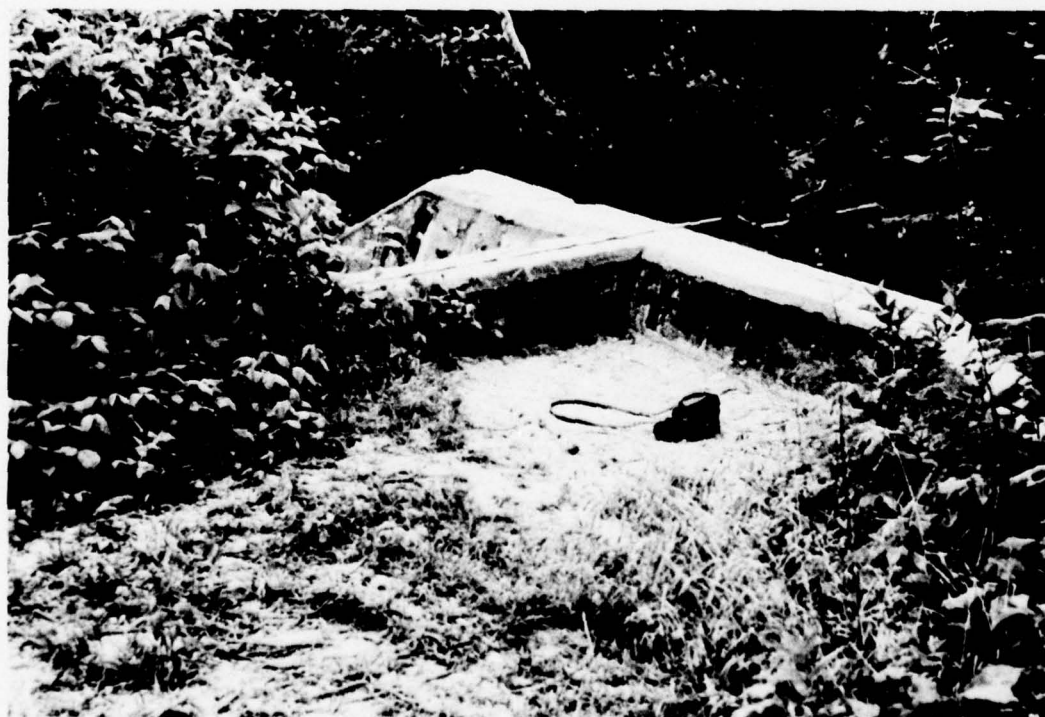
PHOTO 2

Photo 2 - Picture of Left Abutment Wing Wall and Core Wall Showing Low Ground Surface Probably Caused by Erosion and Possibly Some Settlement - 24 June 1978.

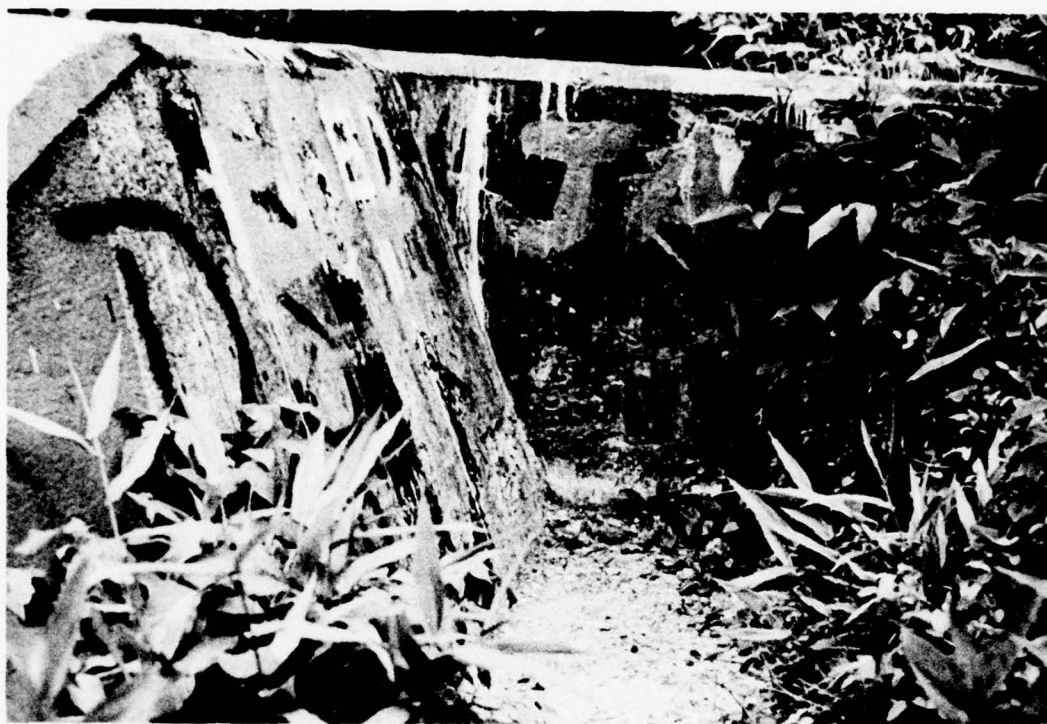
PHOTO 3

Photo 3 - Close-Up of Low Ground Surface at Junction of Wing Wall (Left) and Core Wall - 24 June 1978.

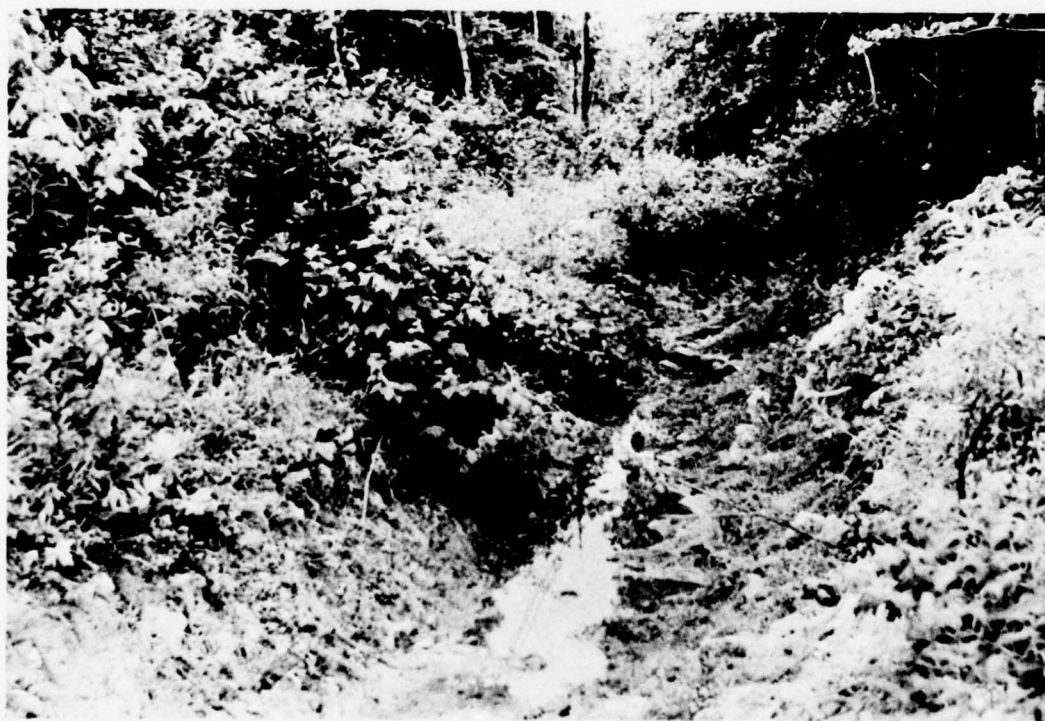
PHOTO 4

Photo 4 - Picture of Recently Excavated Drainage Ditch Which Connects With Downstream Channel Adjacent to Left Abutment Wing Wall (Dike Retaining Lake Sylva Is Located Toward Left of Picture) - 24 June 1978.

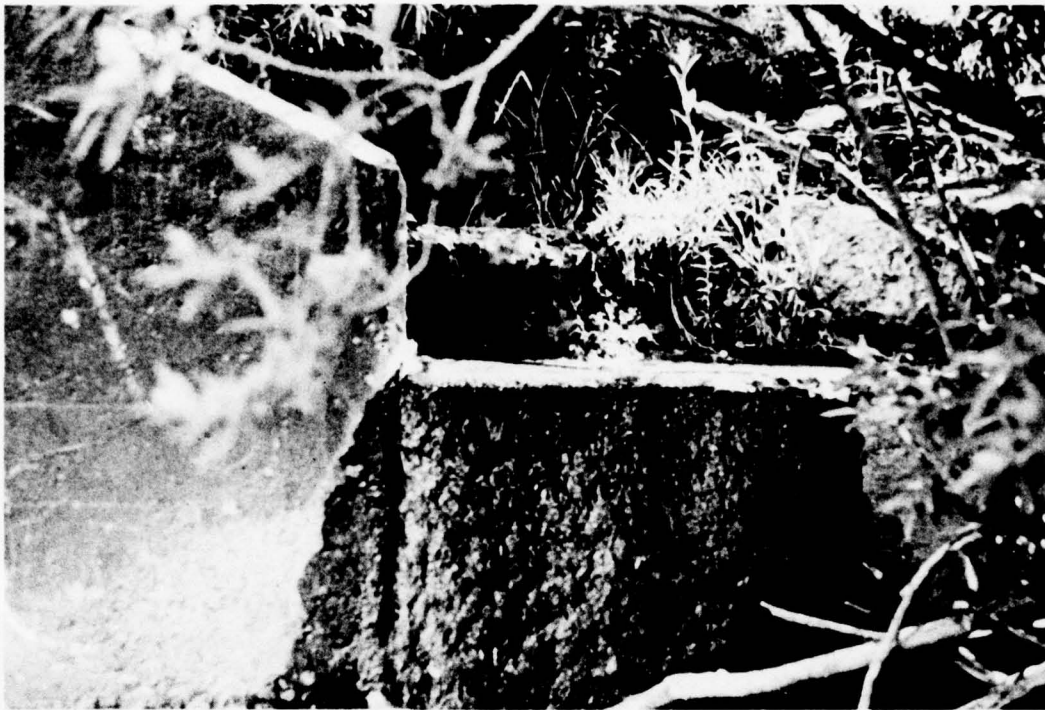
**PHOTO 5**

Photo 5 - Close-Up of Drainage Ditch Discharge Over Small Downstream Channel Wall Adjacent to End of Left Abutment Wing Wall - 24 June 1978.

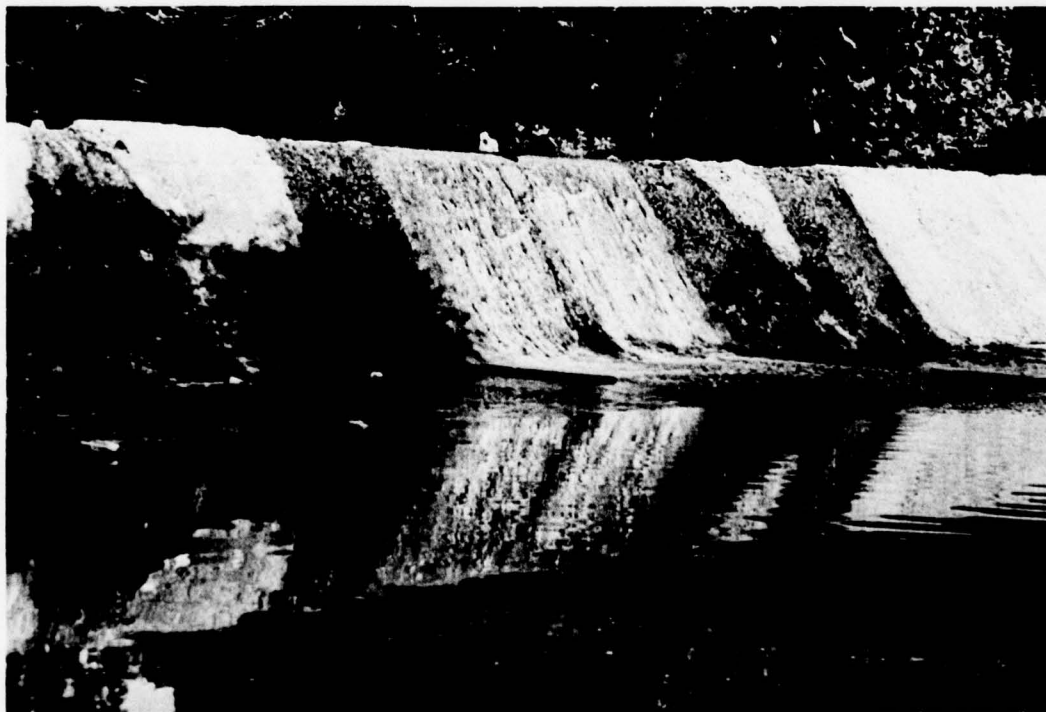
**PHOTO 6**

Photo 6 - View of Spillway Showing Badly Spalled Concrete and Pool in Foreground Formed by Scour of Channel Bottom - 24 June 1978.

(1) Extensive repairs should be made to all spalled and deteriorated concrete on the spillway weir, downstream face of the spillway, spillway wing walls, and discharge channel apron.

(3) Improve outlet channel conditions by removing deposition, trees and debris. The left stream bank should be cleared, shaped and stabilized with properly designed riprap to withstand high stream flows. The scour hole at the end of the spillway apron should be repaired to avoid further damage.

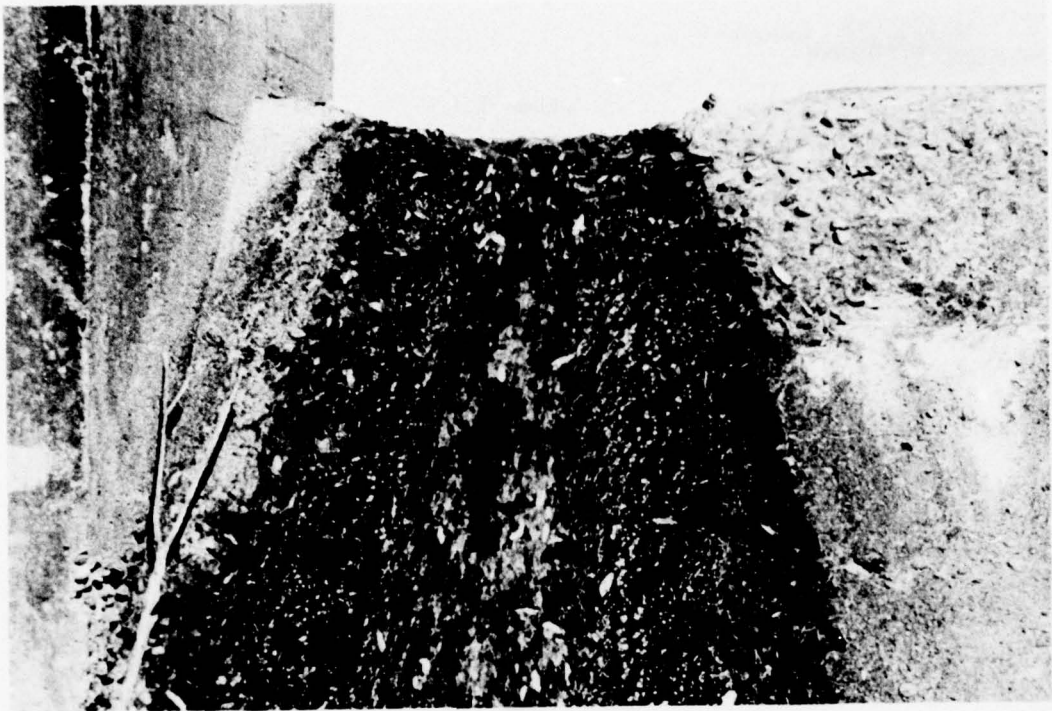
PHOTO 7

Photo 7 - Close-Up of Spillway Adjacent to Right Abutment Showing Badly Spalled Concrete - 24 June 1978.

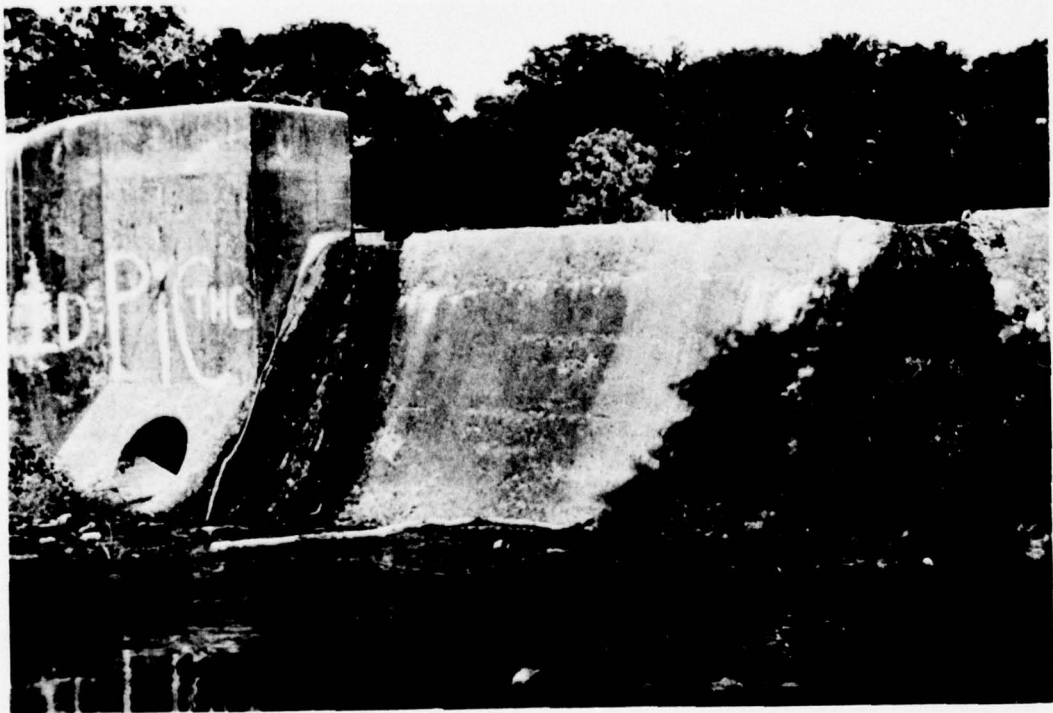
PHOTO 8

Photo 8 - Picture of Portion of Spillway and Right Abutment Showing 24 Inch Diameter Outlet Cast in Concrete - 24 June 1978.

The 24" opening design as a drain for Sylva Lake was closed off and is beneath the silt in the reservoir. Therefore at present it is not functional. However if the silt in the reservoir would be removed and the drain again made operational, the following drawdown would apply.

(2) The gate and outlet works should be repaired as necessary to provide emergency drawdown facilities. Maintenance procedures should be developed and implemented for this facility in the future.

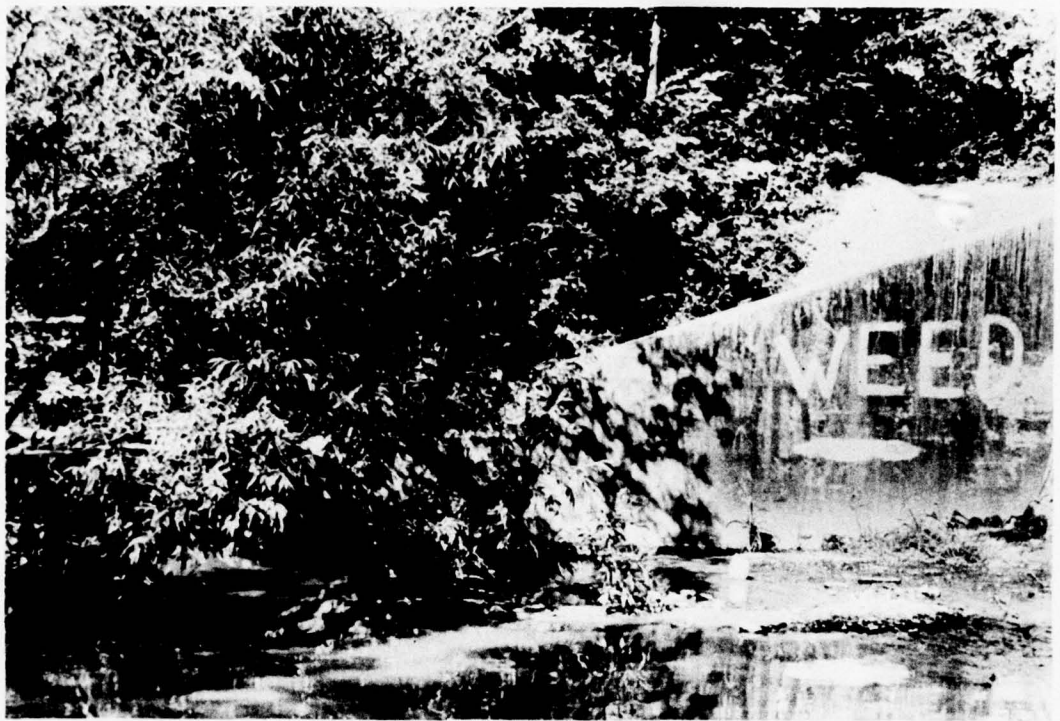
**PHOTO 9**

Photo 9 - View of Downstream End of Right Abutment Wing Wall (Note Eroded Gully Behind Wing Wall, and Heavy Tree and Brush Cover on Embankment) - 24 June 1978.

In the near future, the earth embankment should be cleared of trees and shrubs, properly graded, and reseeded with grass, which should be well maintained.

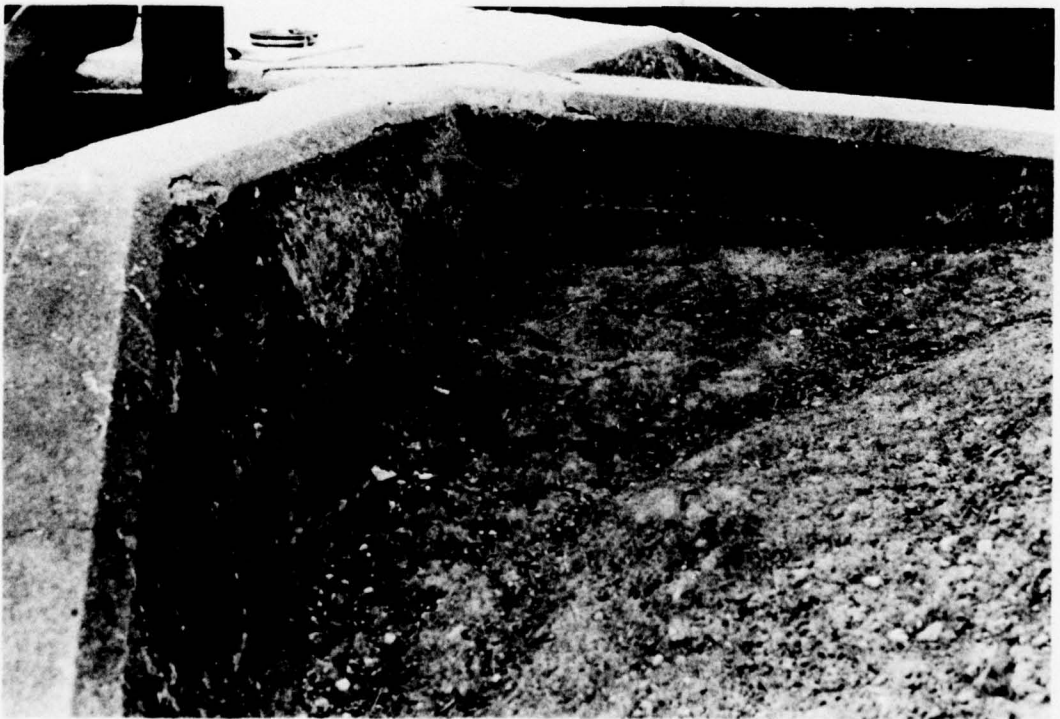
**PHOTO 10**

Photo 10 - Close-Up of Right Abutment Wing Wall and Core Wall (at Right) Showing Low Ground Surface Probably Caused by Erosion and Possibly Some Settlement - 24 June 1978.

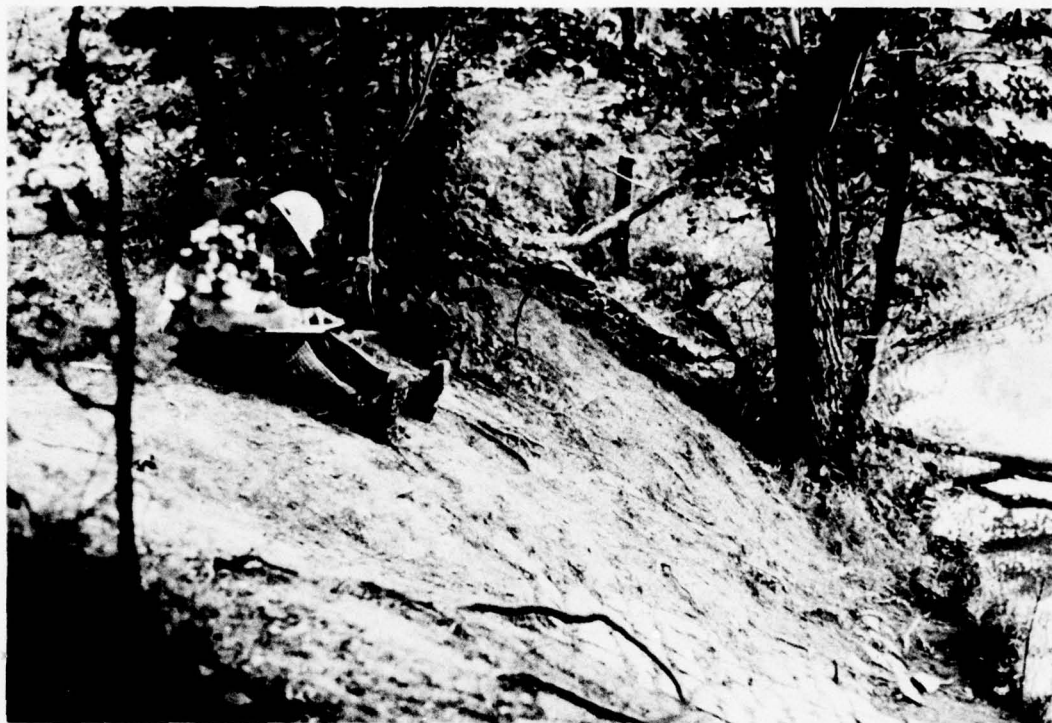
PHOTO 11

Photo 11 - View of Upstream Embankment Slope Near Right Abutment (Note Belgian Block Slope Paving, Mostly Covered With Soil, and Large and Small Trees - 24 June 1978.

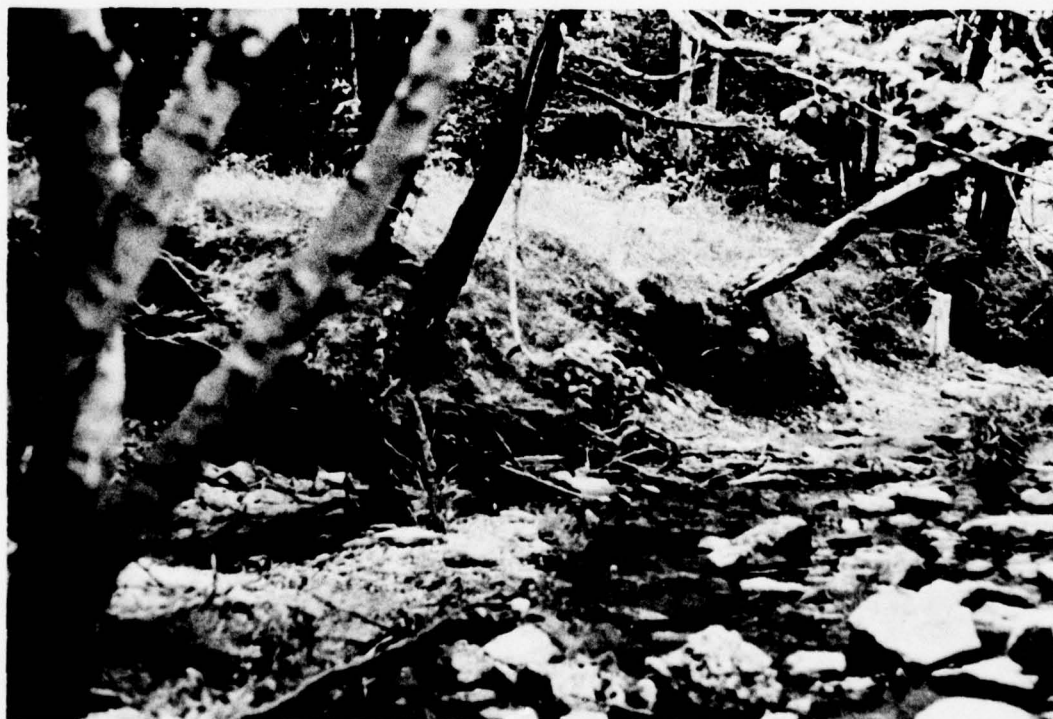
PHOTO 12

Photo 12 - Picture of Downstream Channel Looking Downstream  
(Note Erosion and Undercutting of Bank Causing  
Collapse of Tree Root Systems) - 24 June 1978.

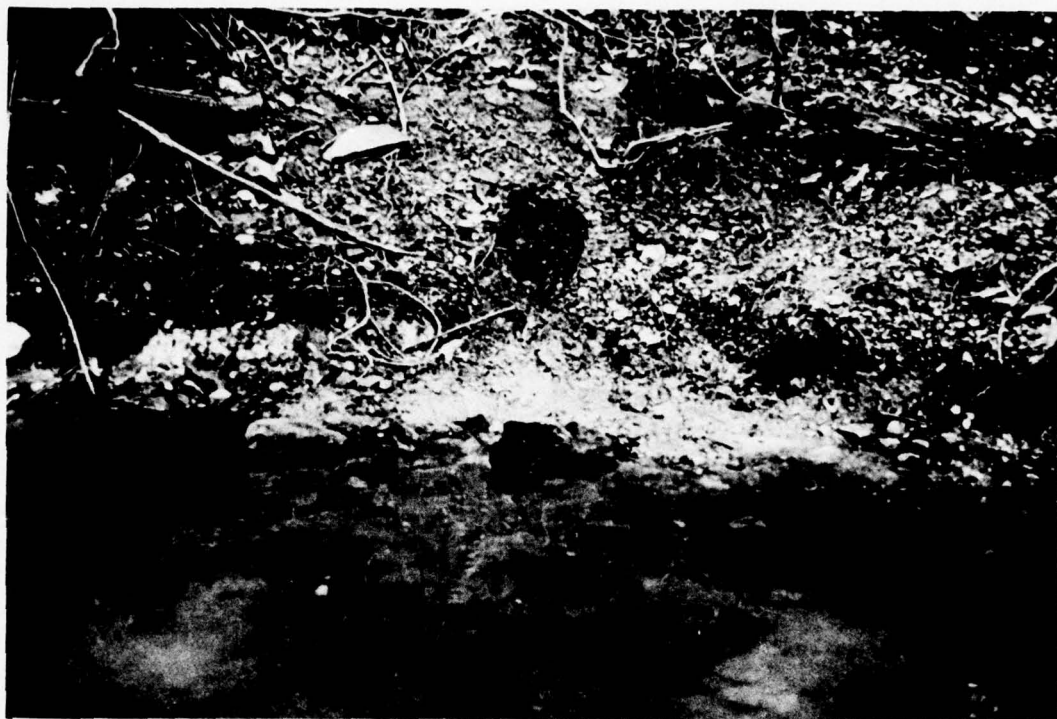
PHOTO 13

Photo 13 - Picture of Very Slight Clear Seepage (Less Than One  
G.P.M.) From Contact of Dense Sand and Gravel With  
Little Silt (Above) With Underlying Very Stiff Gray  
Silt Exposed Just Above Stream Level on Right Bank  
About 100 Feet Downstream From Dam - 24 June 1978.
